**Flood Control Project Maintenance  
Levee Inspections**

## Maintenance Issue Types Only, Levee Inspection Report By Mile - Spring 2017

### Sutter Maintenance Yard Maintenance Area 0003

Waterway	Bank	Unit Miles	Inspection Start/End	Inspector
Unit No. 01 Feather River	Right	5.11	04/06/2017 04/06/2017	Sterling York

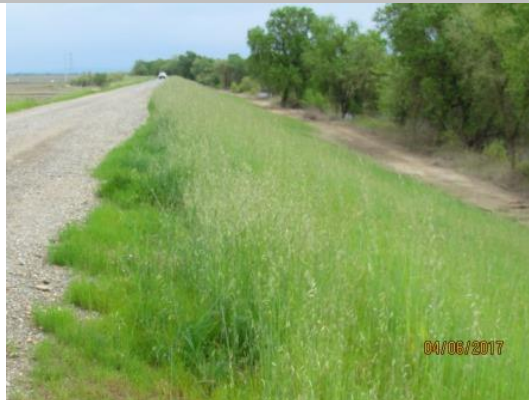
Photo 1 of 1 : SP\_2017\_MA0003\_195\_12\_20170410\_00031.jpg

LM Start	0.01	Rating **	M	Issue No.	12
LM End	5.11	Issue Type +	Ma	Location *	WS
Category	Earthen Levee			GPS Latitude/Longitude	
				Start	End
Item	Vegetation			38.897973 °	38.950881 °
				-121.617817 °	-121.585758 °
DWR ID	DWR_MA0003_01_s_2017_12				
Comment Code					
V1 : Control annual grass and weeds on the levee slopes and easements.					
Inspector Comment					
Annual grasses need to be maintained, Spring 2017.

View looking upstream of annual grasses that need to be maintained, Spring 2017.

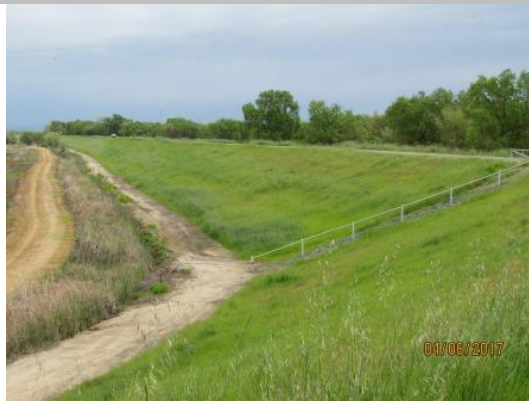
Photo 1 of 1 : SP\_2017\_MA0003\_195\_11\_20170410\_00030.jpg

LM Start	0.01	Rating **	M	Issue No.	11
LM End	5.11	Issue Type +	Ma	Location *	LS
Category	Earthen Levee			GPS Latitude/Longitude	
				Start	End
Item	Vegetation			38.897973 °	38.950881 °
				-121.617816 °	-121.585758 °
DWR ID	DWR_MA0003_01_s_2017_11				
Comment Code					
V1 : Control annual grass and weeds on the levee slopes and easements.					
Inspector Comment					
Annual grasses need to be maintained, Spring 2017.

View looking upstream of annual grasses that need to be maintained, Spring 2017.

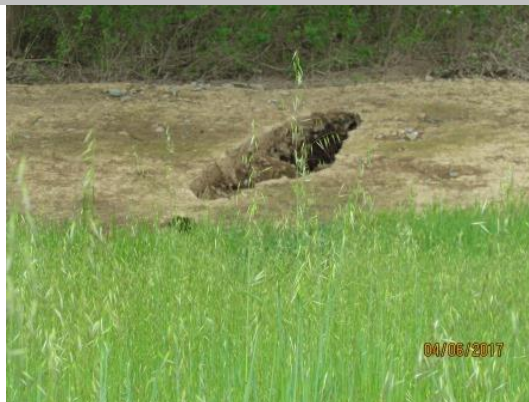
Photo 1 of 1 : SP\_2017\_MA0003\_195\_13\_20170410\_00032.jpg

LM Start	0.42	Rating **	M	Issue No.	13
LM End	0.42	Issue Type +	Ma	Location *	WS
Category	Earthen Levee			GPS Latitude/Longitude	
				Start	End
Item	Animal Control			38.900811 °	38.900811 °
				-121.611604 °	-121.611604 °
DWR ID	DWR_MA0003_01_s_2017_13				
Comment Code					
A1 : Exterminate rodents and backfill and compact or grout burrows.					
Inspector Comment					
A large hole on the waterside that look to be from a large animal needs repair, Spring 2017.

View of a large hole on the waterside that look to be from a large animal, Spring 2017.

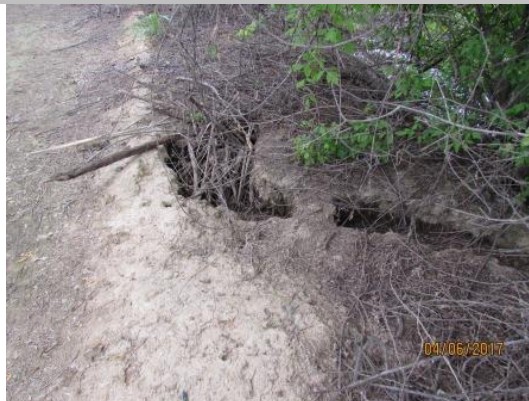
Photo 1 of 1 : SP\_2017\_MA0003\_195\_17\_20170410\_00033.jpg

LM Start	0.69	Rating **	M	Issue No.	17
LM End	0.69	Issue Type +	Ma	Location *	LS
Category	Earthen Levee			GPS Latitude/Longitude	
				Start	End
Item	Animal Control			38.903352 °	38.903352 °
				-121.607829 °	-121.607829 °
DWR ID	DWR_MA0003_01_s_2017_17				
Comment Code					
A1 : Exterminate rodents and backfill and compact or grout burrows.					
Inspector Comment					
A large hole on the lanside that look to be from a large animal needs to be repaired, Spring 2017.

View of a large hole on the landside that look to be from a large animal, Spring 2017.

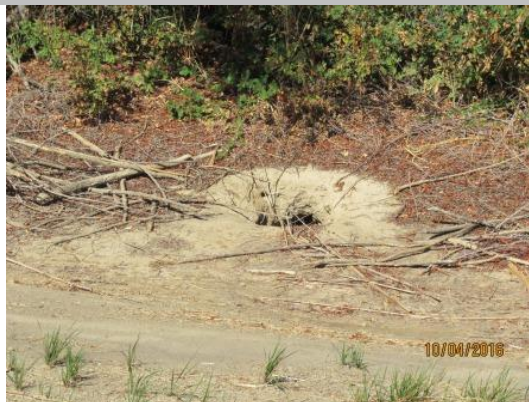
Photo 1 of 2 : SP\_2017\_MA0003\_195\_140\_20170316\_00013.jpg

LM Start	0.78	Rating **	M	Issue No.	140
LM End	0.78	Issue Type +	Ma	Location *	LS
Category	Earthen Levee			GPS Latitude/Longitude	
				Start	End
Item	Animal Control			38.903339 °	38.903339 °
				-121.606209 °	-121.606209 °
DWR ID	DWR_MA0003_01_f_2014_140				
Comment Code					
A3 : No rodents visible, but rodent burrows visible; need to backfill and compact or grout burrows.					
Inspector Comment					
There is a rodent hole on the landward toe road approximately 8" in diameter that needs to be repaired. Fall 2016.

This photo was taken from the landward levee slope near the toe road facing north looking at an approximately 8" rodent hole. Fall 2016.

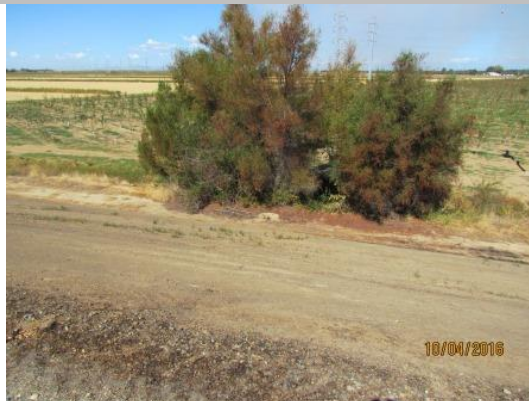
Photo 2 of 2 : SP\_2017\_MA0003\_195\_140\_20170316\_00014.jpg

LM Start	0.78	Rating **	M	Issue No.	140 (cont)
LM End	0.78	Issue Type +	Ma	Location *	LS
Category	Earthen Levee			GPS Latitude/Longitude	
				Start	End
Item	Animal Control			38.903339 °	38.903339 °
				-121.606209 °	-121.606209 °
DWR ID	DWR_MA0003_01_f_2014_140				
Comment Code					
A3 : No rodents visible, but rodent burrows visible; need to backfill and compact or grout burrows.					
Inspector Comment					
There is a rodent hole on the landward toe road approximately 8" in diameter that needs to be repaired. Fall 2016.

This is another photo of the rodent hole to show its relationship to levee toe, toe road, and drainage ditch. Fall 2016.

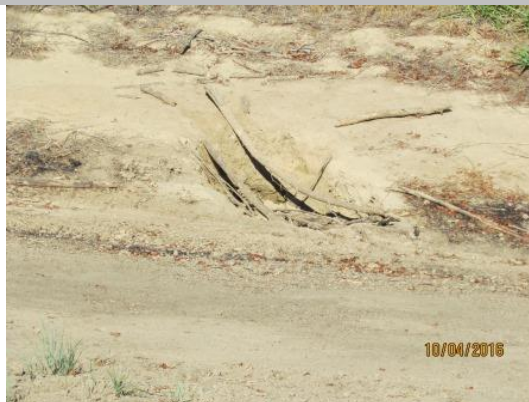
Photo 1 of 2 : SP\_2017\_MA0003\_195\_21\_20170316\_00011.jpg

LM Start	0.80	Rating **	M	Issue No.	21
LM End	0.80	Issue Type +	Ma	Location *	LS
Category	Earthen Levee			GPS Latitude/Longitude	
				Start	End
Item	Animal Control			38.903277 °	38.903277 °
				-121.605864 °	-121.605864 °
DWR ID	DWR_MA0003_01_f_2016_21				
Comment Code					
A3 : No rodents visible, but rodent burrows visible; need to backfill and compact or grout burrows.					
Inspector Comment					
Repair animal hole at landside levee toe. Fall 2016.

View of large hole at the landside levee toe. Look to be cause by a larger animal other than squirrels. Fall 2016.

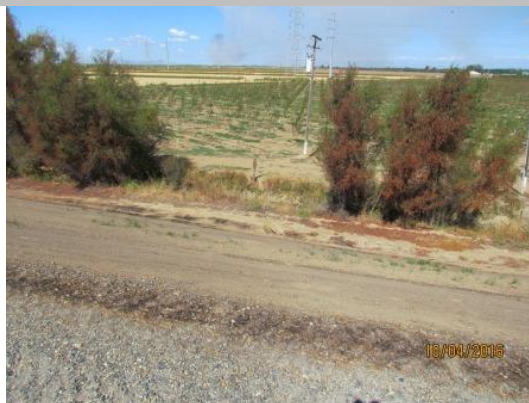
Photo 2 of 2 : SP\_2017\_MA0003\_195\_21\_20170316\_00012.jpg

LM Start	0.80	Rating **	M	Issue No.	21 (cont)	
LM End	0.80	Issue Type +	Ma	Location *	LS	
Category	Earthen Levee			GPS Latitude/Longitude		
				Start		End
Item	Animal Control			38.903277 °		38.903277 °
				-121.605864 °		-121.605864 °
DWR ID	DWR_MA0003_01_f_2016_21					
Comment Code						
A3 : No rodents visible, but rodent burrows visible; need to backfill and compact or grout burrows.						
Inspector Comment						
Repair animal hole at landside levee toe. Fall 2016.

View from the crown of where this hole is. Fall 2016.

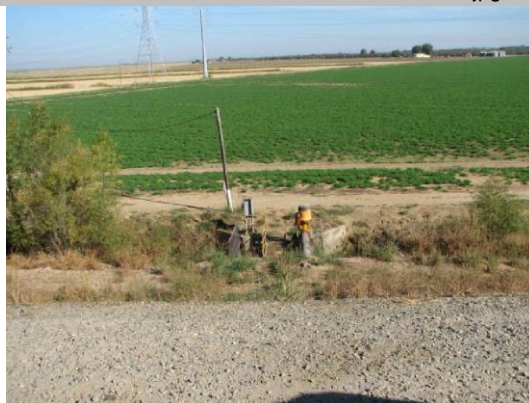
Photo 1 of 3 : UCIP\_SP\_2017\_51474\_64649.jpg

FS\_ID:51474  
DS\_ID:17092  
EP\_NO: N/A  
Repair Type: Urgent  
Crossing Status: Found  
UCIP Comments: 4/11/2017 Water levels were high on WS during inspection so pipe ends could not be inspected. Believe that the sandbags are still in place and condition of flap gates is unknown. (DWR Sutter Yard- A Freitag)10/10/2016 WS pipe end was underwater for inspection but the sandbags still appear to be in place. (DWR Sutter Yard - a Freitag)4/18/2016 No repairs have been made to the pipe yet. (DWR Sutter Yard - a Freitag)5/12/2015 Water level high in WS ditch so could not see WS end of crossing. Do not believe that repairs have been made yet. (DWR Sutter Yard - a Freitag)11/17/2014 Same as last inspection. (DWR Sutter Yard - a Freitag)5/14/2014 Same as last inspection. (DWR Sutter Yard - a Freitag)10/30/2013 Same as last inspection. (DWR Sutter Yard - a Freitag)5/21/2013 SBFCA project recommends replacing in accordance with title 23. High water levels in WS ditch have pipe ends underwater but repairs have not yet been completed but are planned for when water levels drop. (DWR Sutter Yard - a Freitag)10/10/2012 Flap gates not visible on waterward headwall and it appears as though they have been replaced by sandbags. Slide gates on LS appear to be closed yet water leaks excessively from the WS at the sandbagged headwall. (DWR UCIP - wwwylie)

Concrete headwall with walkway and slide gates at LS toe.

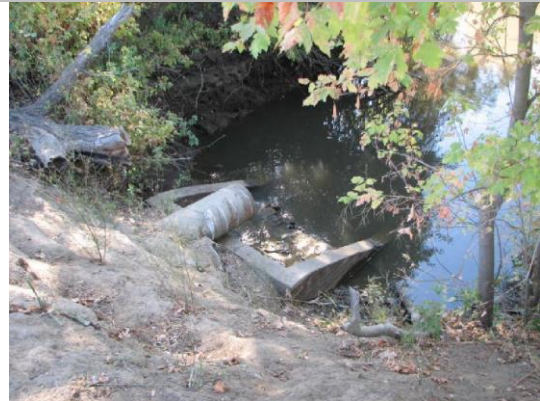
Photo 2 of 3 : UCIP\_SP\_2017\_51474\_64648.jpg

FS\_ID:51474  
DS\_ID:17092  
EP\_NO: N/A  
Repair Type: Urgent  
Crossing Status: Found  
UCIP Comments: 4/11/2017 Water levels were high on WS during inspection so pipe ends could not be inspected. Believe that the sandbags are still in place and condition of flap gates is unknown. (DWR Sutter Yard- A Freitag)10/10/2016 WS pipe end was underwater for inspection but the sandbags still appear to be in place. (DWR Sutter Yard - a Freitag)4/18/2016 No repairs have been made to the pipe yet. (DWR Sutter Yard - a Freitag)5/12/2015 Water level high in WS ditch so could not see WS end of crossing. Do not believe that repairs have been made yet. (DWR Sutter Yard - a Freitag)11/17/2014 Same as last inspection. (DWR Sutter Yard - a Freitag)5/14/2014 Same as last inspection. (DWR Sutter Yard - a Freitag)10/30/2013 Same as last inspection. (DWR Sutter Yard - a Freitag)5/21/2013 SBFCA project recommends replacing in accordance with title 23. High water levels in WS ditch have pipe ends underwater but repairs have not yet been completed but are planned for when water levels drop. (DWR Sutter Yard - a Freitag)10/10/2012 Flap gates not visible on waterward headwall and it appears as though they have been replaced by sandbags. Slide gates on LS appear to be closed yet water leaks excessively from the WS at the sandbagged headwall. (DWR UCIP - wwwylie)

Concrete U shaped headwall on WS toe filled in with Sandbags. 16-inch pipe shown over top of headwall.

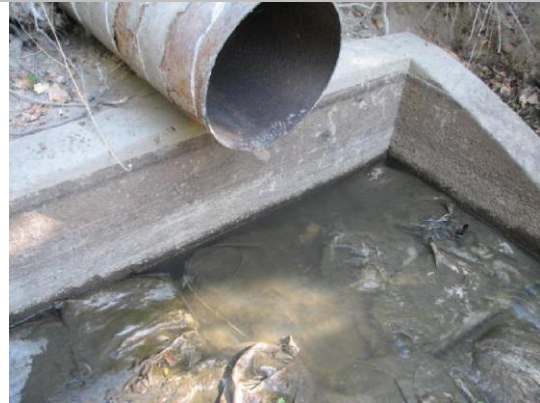
Photo 3 of 3 : UCIP\_SP\_2017\_51474\_64647.jpg

FS\_ID:51474  
DS\_ID:17092  
EP\_NO: N/A  
Repair Type: Urgent  
Crossing Status: Found  
UCIP Comments: 4/11/2017 Water levels were high on WS during inspection so pipe ends could not be inspected. Believe that the sandbags are still in place and condition of flap gates is unknown. (DWR Sutter Yard- A Freitag)10/10/2016 WS pipe end was underwater for inspection but the sandbags still appear to be in place. (DWR Sutter Yard - a Freitag)4/18/2016 No repairs have been made to the pipe yet. (DWR Sutter Yard - a Freitag)5/12/2015 Water level high in WS ditch so could not see WS end of crossing. Do not believe that repairs have been made yet. (DWR Sutter Yard - a Freitag)11/17/2014 Same as last inspection. (DWR Sutter Yard - a Freitag)5/14/2014 Same as last inspection. (DWR Sutter Yard - a Freitag)10/30/2013 Same as last inspection. (DWR Sutter Yard - a Freitag)5/21/2013 SBFCA project recommends replacing in accordance with title 23. High water levels in WS ditch have pipe ends underwater but repairs have not yet been completed but are planned for when water levels drop. (DWR Sutter Yard - a Freitag)10/10/2012 Flap gates not visible on waterward headwall and it appears as though they have been replaced by sandbags. Slide gates on LS appear to be closed yet water leaks excessively from the WS at the sandbagged headwall. (DWR UCIP - wwwylie)

Concrete U shaped headwall filled in with sandbags on WS toe. Flap gates appear to be missing and water readily flows through the sandbags from LS.

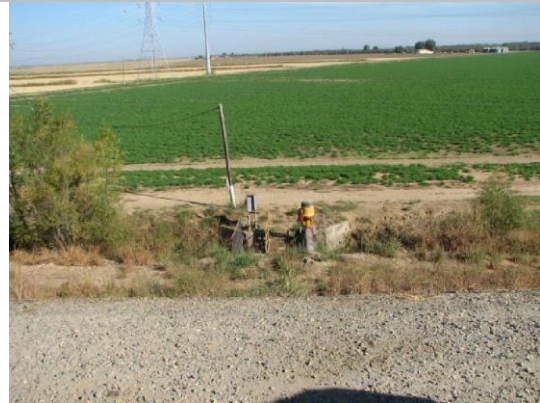
Photo 1 of 3 : UCIP\_SP\_2017\_51475\_64662.jpg

FS\_ID:51475  
DS\_ID:17136  
EP\_NO: N/A  
Repair Type: Urgent  
Crossing Status: Found  
UCIP Comments: 4/11/2017 Water levels were high on WS during inspection so pipe ends could not be inspected. Believe that the sandbags are still in place and condition of flap gates is unknown. (DWR Sutter Yard - afreitag)10/10/2016 WS pipe end was underwater for the inspection but the sandbags appear to still be in place. (DWR Sutter Yard - afreitag)4/18/2016 No repairs have been made to the pipe yet. (DWR Sutter Yard - afreitag)5/12/2015 Water level high in WS ditch so could not see WS end of crossing. Do not believe that repairs have been made yet. (DWR Sutter Yard - afreitag)11/17/2014 Same as last inspection. (DWR Sutter Yard - afreitag)5/14/2014 Same as last inspection. (DWR Sutter Yard - afreitag)10/30/2013 Same as last inspection. (DWR Sutter Yard - afreitag)5/21/2013 SBFCA project recommends replacing in accordance with title 23. High water levels in WS ditch have pipe ends underwater but repairs have not yet been completed but are planned for when water levels drop. (DWR Sutter Yard - afreitag)10/10/2012 Flap gates not visible on waterward headwall and it appears as though they have been replaced by sandbags. Slide gates on LS appear to be closed yet water leaks excessively from the WS at the sandbagged headwall. (DWR UCIP - wwwylie)

Concrete headwall, slidegates, and metal walkway on LS toe.

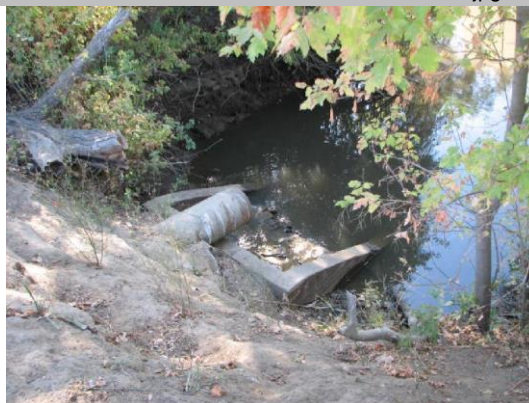
Photo 2 of 3 : UCIP\_SP\_2017\_51475\_64661.jpg

FS\_ID:51475  
DS\_ID:17136  
EP\_NO: N/A  
Repair Type: Urgent  
Crossing Status: Found  
UCIP Comments: 4/11/2017 Water levels were high on WS during inspection so pipe ends could not be inspected. Believe that the sandbags are still in place and condition of flap gates is unknown. (DWR Sutter Yard - afreitag)10/10/2016 WS pipe end was underwater for the inspection but the sandbags appear to still be in place. (DWR Sutter Yard - afreitag)4/18/2016 No repairs have been made to the pipe yet. (DWR Sutter Yard - afreitag)5/12/2015 Water level high in WS ditch so could not see WS end of crossing. Do not believe that repairs have been made yet. (DWR Sutter Yard - afreitag)11/17/2014 Same as last inspection. (DWR Sutter Yard - afreitag)5/14/2014 Same as last inspection. (DWR Sutter Yard - afreitag)10/30/2013 Same as last inspection. (DWR Sutter Yard - afreitag)5/21/2013 SBFCA project recommends replacing in accordance with title 23. High water levels in WS ditch have pipe ends underwater but repairs have not yet been completed but are planned for when water levels drop. (DWR Sutter Yard - afreitag)10/10/2012 Flap gates not visible on waterward headwall and it appears as though they have been replaced by sandbags. Slide gates on LS appear to be closed yet water leaks excessively from the WS at the sandbagged headwall. (DWR UCIP - wwwylie)

Concrete U shaped headwall on WS toe filled with sandbags.

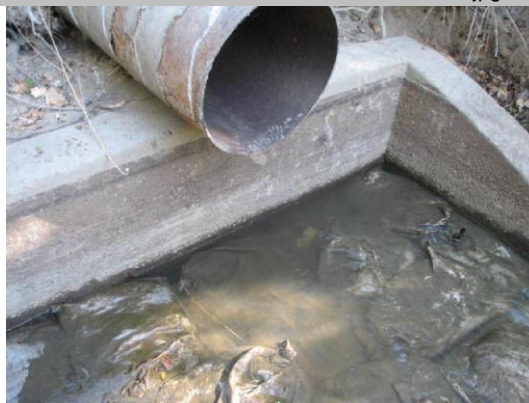
Photo 3 of 3 : UCIP\_SP\_2017\_51475\_64660.jpg

FS\_ID:51475  
DS\_ID:17136  
EP\_NO: N/A  
Repair Type: Urgent  
Crossing Status: Found  
UCIP Comments: 4/11/2017 Water levels were high on WS during inspection so pipe ends could not be inspected. Believe that the sandbags are still in place and condition of flap gates is unknown. (DWR Sutter Yard- afreitag)10/10/2016 WS pipe end was underwater for the inspection but the sandbags appear to still be in place. (DWR Sutter Yard - afreitag)4/18/2016 No repairs have been made to the pipe yet. (DWR Sutter Yard - afreitag)5/12/2015 Water level high in WS ditch so could not see WS end of crossing. Do not believe that repairs have been made yet. (DWR Sutter Yard - afreitag)11/17/2014 Same as last inspection. (DWR Sutter Yard - afreitag)5/14/2014 Same as last inspection. (DWR Sutter Yard - afreitag)10/30/2013 Same as last inspection. (DWR Sutter Yard - afreitag)5/21/2013 SBFCA project recommends replacing in accordance with title 23. High water levels in WS ditch have pipe ends underwater but repairs have not yet been completed but are planned for when water levels drop. (DWR Sutter Yard - afreitag)10/10/2012 Flap gates not visible on waterward headwall and it appears as though they have been replaced by sandbags. Slide gates on LS appear to be closed yet water leaks excessively from the WS at the sandbagged headwall. (DWR UCIP - wwwylie)

Flap gates appear to be missing from U shaped headwall. Sandbags fill headwall but water flows heavily from LS.

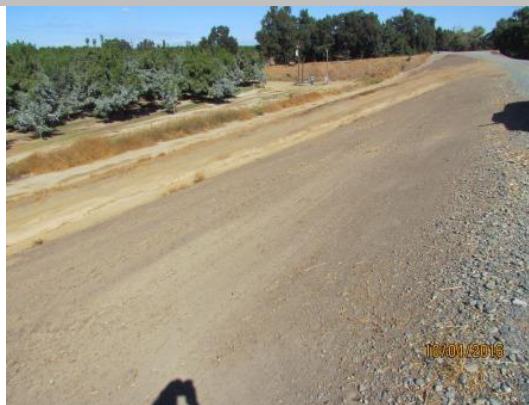
Photo 1 of 1 : SP\_2017\_MA0003\_195\_14\_20170316\_00005.jpg

LM Start	1.77	Rating **	A/W	Issue No.	14
LM End	1.77	Issue Type +	Ma	Location *	LS
Category	Earthen Levee			GPS Latitude/Longitude	
				Start	End
Item	Animal Control			38.907025 °	38.907025 °
				-121.590375 °	-121.590375 °
DWR ID	DWR_MA0003_01_s_2015_14				
Comment Code					
A3 : No rodents visible, but rodent burrows visible; need to backfill and compact or grout burrows.					
Inspector Comment					
Rodent holes have been backfilled and no new evidenced of activity. Fall 2016.

Rodent holes were backfilled and no longer exist at this location. Fall 2016.

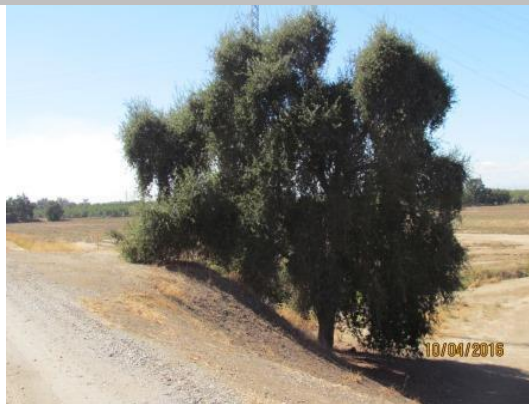
Photo 1 of 1 : SP\_2017\_MA0003\_195\_15\_20170316\_00006.jpg

LM Start	2.18	Rating **	M	Issue No.	15
LM End	2.18	Issue Type +	Ma	Location *	WS
Category	Earthen Levee			GPS Latitude/Longitude	
				Start	End
Item	Trim / Thin Trees			38.911869 °	38.911869 °
				-121.586093 °	-121.586093 °
DWR ID	DWR_MA0003_01_s_2015_15				
Comment Code					
T1 : Trim trees to at least five feet above ground level.					
Inspector Comment					
Tree is at a turnout and not in the levee, but limbs should be trimmed for access and visibility.

View of tree at a turnout that needs to have its limbs trimmed for visibility and access, landside looking downstream. Fall 2016.

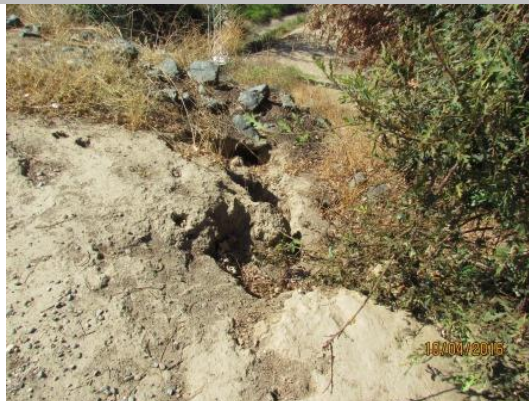
Photo 1 of 1 : SP\_2017\_MA0003\_195\_18\_20170316\_00008.jpg

LM Start	2.18	Rating **	A/W	Issue No.	18
LM End	2.18	Issue Type +	Ma	Location *	LS
Category	Earthen Levee			GPS Latitude/Longitude	
				Start	End
Item	Animal Control			38.911869 °	38.911869 °
				-121.586093 °	-121.586093 °
DWR ID	DWR_MA0003_01_s_2015_18				
Comment Code					
A3 : No rodents visible, but rodent burrows visible; need to backfill and compact or grout burrows.					
Inspector Comment

View of rodent holes that need to be backfilled, No evidence of rodents during inspection. Fall 2016.

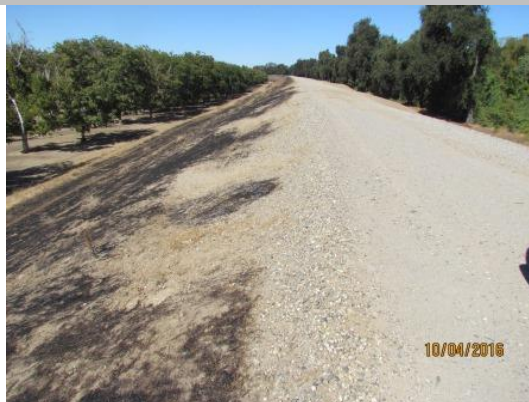
Photo 1 of 1 : SP\_2017\_MA0003\_195\_20\_20170316\_00010.jpg

LM Start	3.20	Rating **	A/W	Issue No.	20
LM End	3.20	Issue Type +	Ma	Location *	LS
Category	Earthen Levee			GPS Latitude/Longitude	
				Start	End
Item	Slope Stability			38.925909 °	38.925909 °
				-121.585401 °	-121.585401 °
DWR ID	DWR_MA0003_01_s_2015_20				
Comment Code					
S1 : Repair slope instability.					
Inspector Comment

View of the inconsistent slope that makes the crown narrower were it dips in and out, but no evidence of slope erosion or sloughing. Fall 2016.

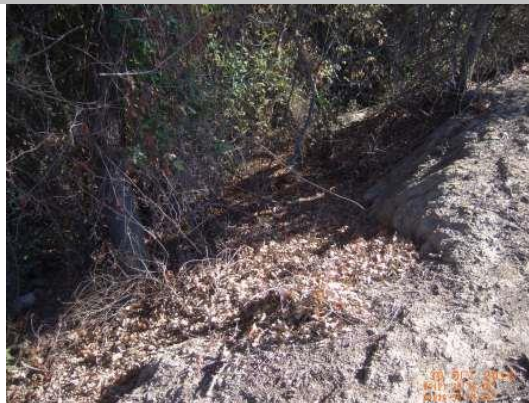
Photo 1 of 2 : SP\_2017\_MA0003\_195\_1\_20170316\_00001.jpg

LM Start	4.15	Rating **	M	Issue No.	1
LM End	4.18	Issue Type +	Ma	Location *	WS
Category	Supplemental			GPS Latitude/Longitude	
				Start	End
Item	2015 USACE Erosion Survey, DRAFT			38.937451 °	38.937937 °
				-121.588512 °	-121.588471 °
DWR ID	DWR_MA0003_01_s_2016_1				
Comment Code					
Inspector Comment					
2013 - Minor toe scour causing gradual erosion of bank slope. Site is within ecological reserve. 2015: Last observed in 2013. [2015 Site ID: FHR_12-3_R]

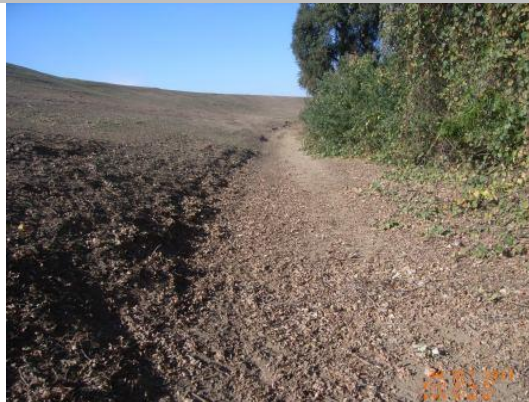
Photo 1 of 2 : SP\_2017\_MA0003\_195\_2\_20170316\_00003.jpg

LM Start	4.71	Rating **	M	Issue No.	2
LM End	4.76	Issue Type +	Ma	Location *	WS
Category	Supplemental			GPS Latitude/Longitude	
				Start	End
Item	2015 USACE Erosion Survey, DRAFT			38.945188 °	38.945958 °
				-121.586096 °	-121.586394 °
DWR ID	DWR_MA0003_01_s_2016_2				
Comment Code					
Inspector Comment					
2013 - Minor toe scour causing gradual erosion into the bank slope.					
2015: Last observed in 2013. [2015 Site ID: FHR_12-8_R]

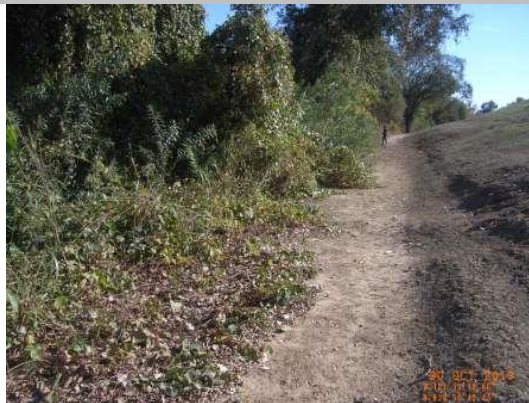
Photo 2 of 2 : SP\_2017\_MA0003\_195\_2\_20170316\_00004.jpg

LM Start	4.71	Rating **	M	Issue No.	2 (cont)	
LM End	4.76	Issue Type +	Ma	Location *	WS	
Category	Supplemental			GPS Latitude/Longitude		
				Start		End
Item	2015 USACE Erosion Survey, DRAFT			38.945188 °	38.945958 °	
				-121.586096 °	-121.586394 °	
DWR ID	DWR_MA0003_01_s_2016_2					
Comment Code						
Inspector Comment						
2013 - Minor toe scour causing gradual erosion into the bank slope.						
2015: Last observed in 2013. [2015 Site ID: FHR_12-8_R]
